jOiNEd For sUsTainability - bUilding climate REsilient communities in WB and EU

Energy efficiency improvement measures for renovation of modernist buildings heritage

Liljana D. Sofronievska,
Faculty of Architecture,
Ss. Cyril and Methodius University, Skopje

03.07.2024
Ohrid

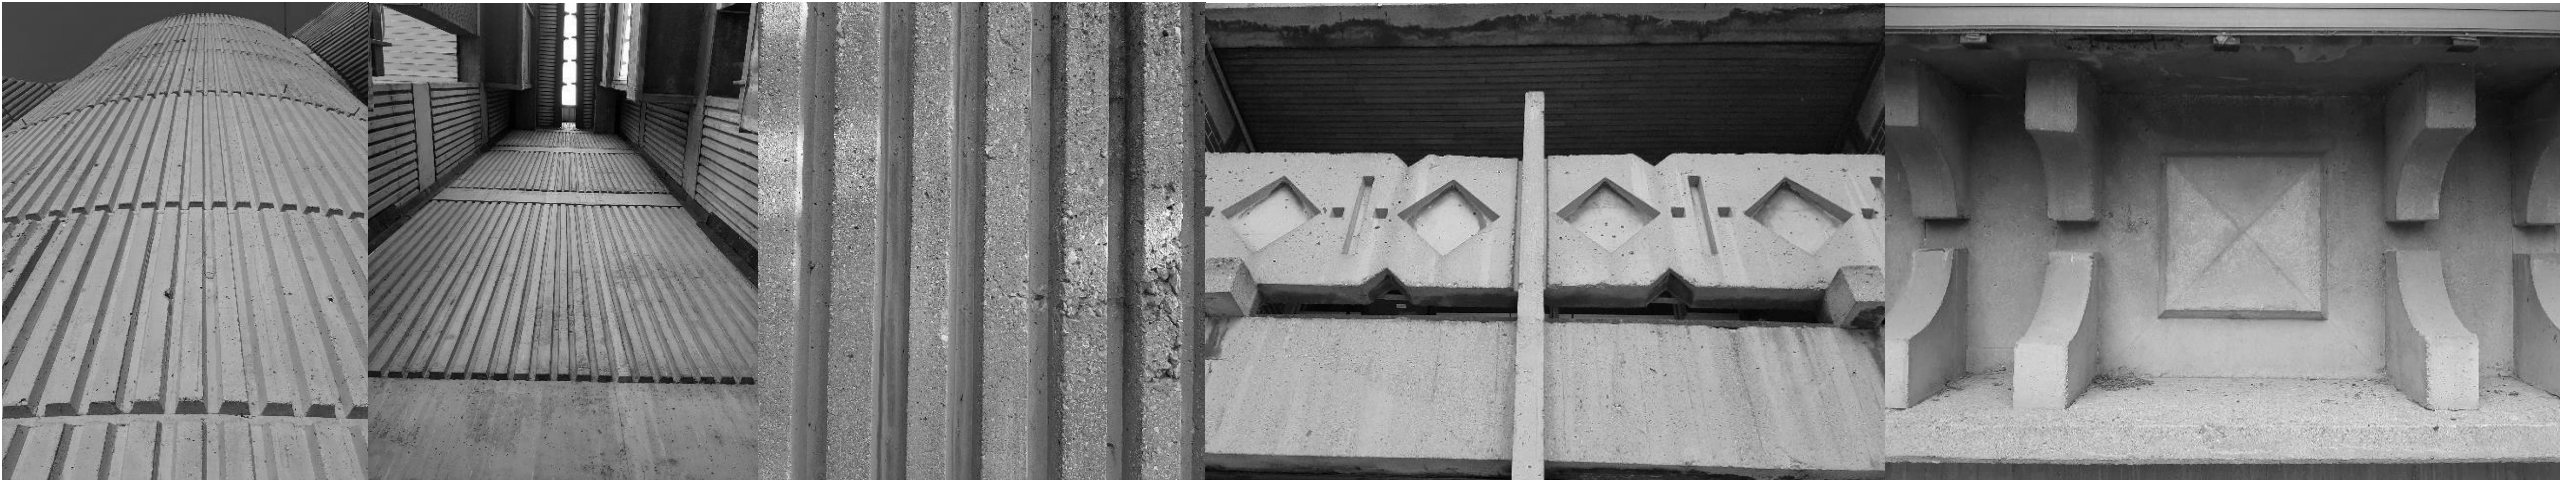
3.1. Detecting the most vulnerable category of modernist buildings

Key problems with "brutalist" buildings:

- High coefficient of thermal conductivity λ W/(Km)
- High thermal mass
- Exposure and vulnerability to external influences
- Losing authenticity by isolating the envelope
- Disadvantages in insulating the buildings from the inside
- Specific architectural facade design
- Large representation of natural concrete buildings

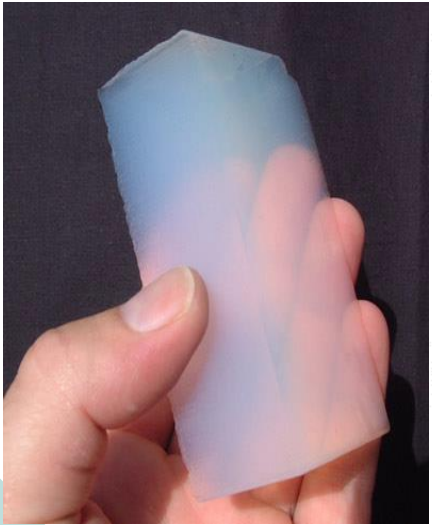
Nano porous structure of aerogel thermal insulation material

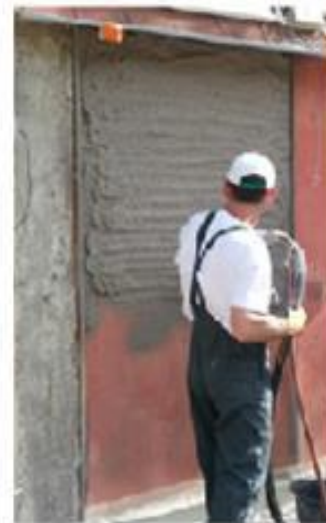
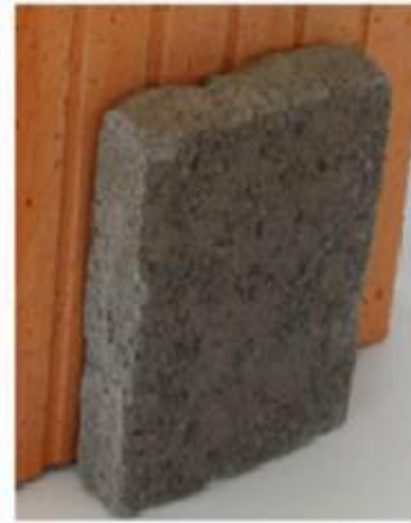
Silica aerogel based thermal mortar – methods of façade wall application

Thermal properties of silica aerogel thermal plaster

Aerogel based thermal insulation plaster thermal properties

λ (W/mK)	0.028
c (J/kgK)	990
ρ (kg/m ³)	220
d (m)	0.06
μ [-]	4-5

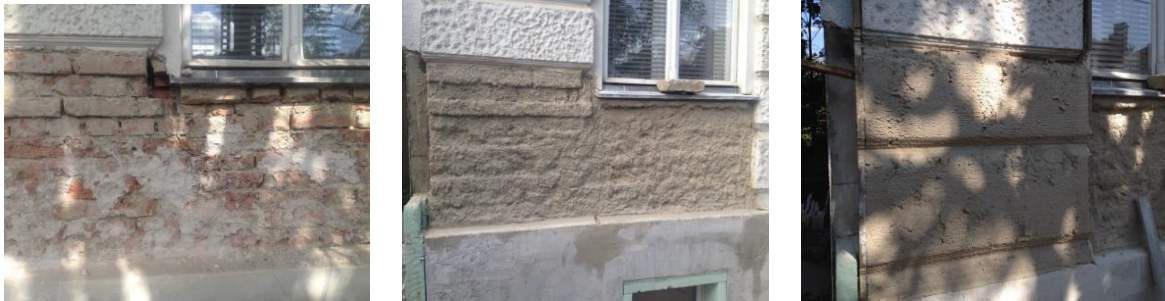
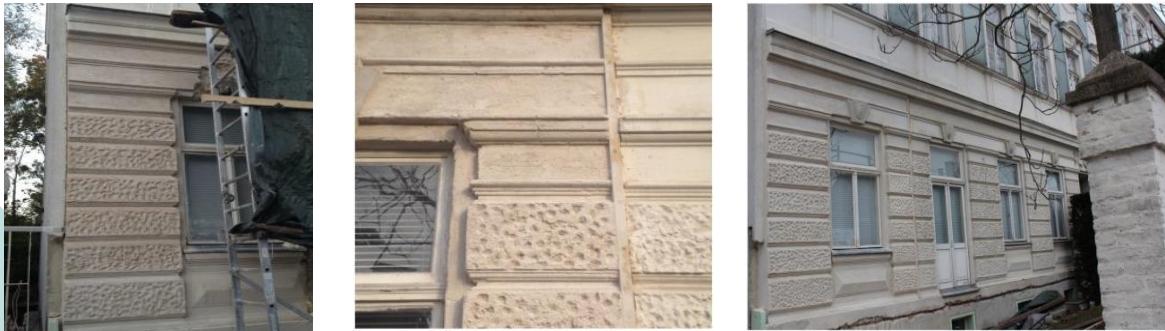
Renovation of a historical building façade with aerogel thermal plaster

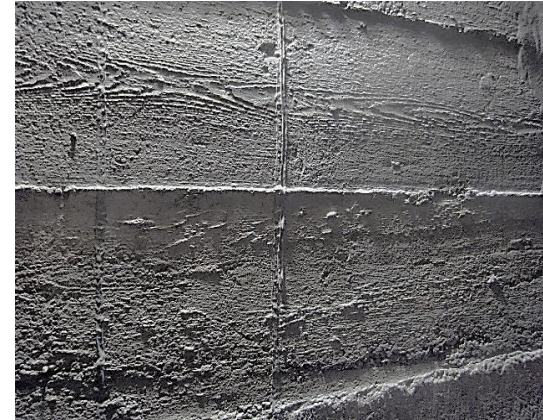
Natural concrete façade "beton-brut"

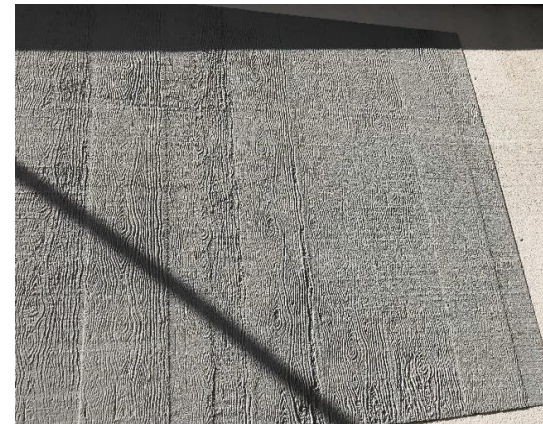
Façade material (aerogel plaster) with concrete texture

Aerogel thermal plaster is a very promising material for modernist heritage renovation

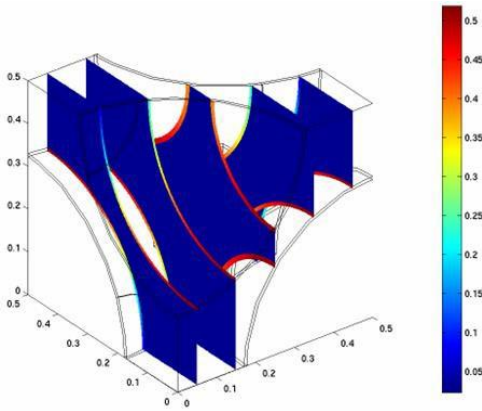
Model of the nano structure of ceramic spheres in the nano coating façade material

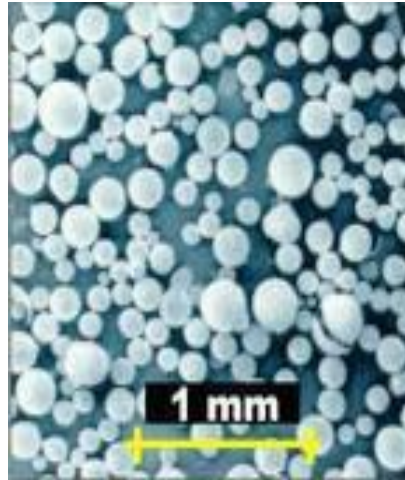
Nano size of spheres

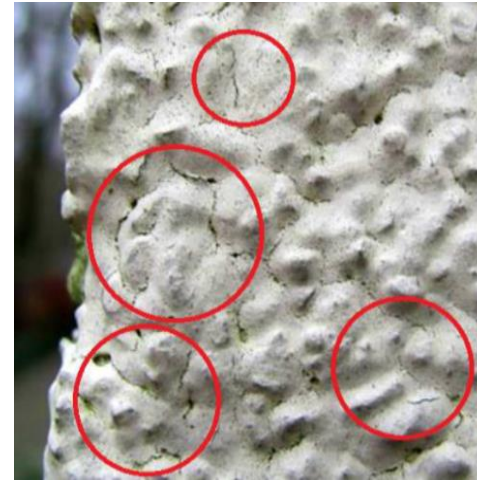
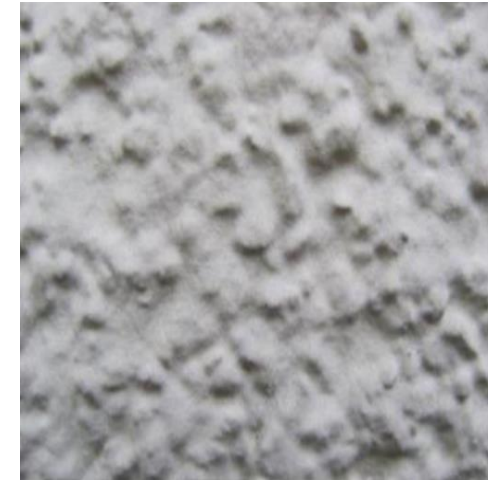
Deformations of different facades a) facade coated with conventional paint; b) facade coated with nanocoating

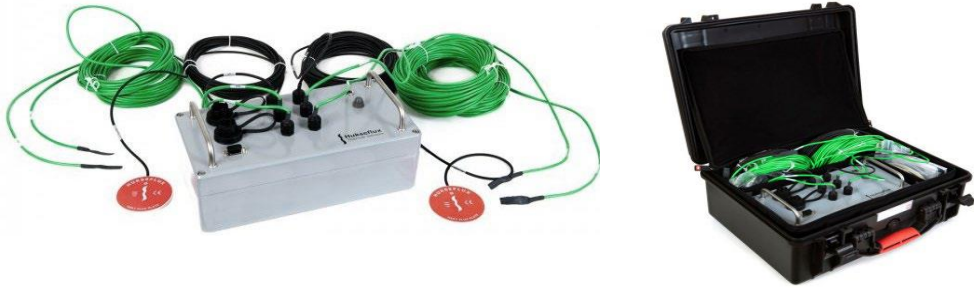
Measuring equipment with data logger - TRSYS01 – HFM

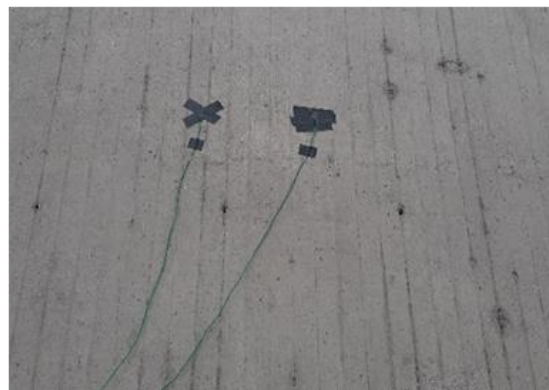
Outside heat flux measurements

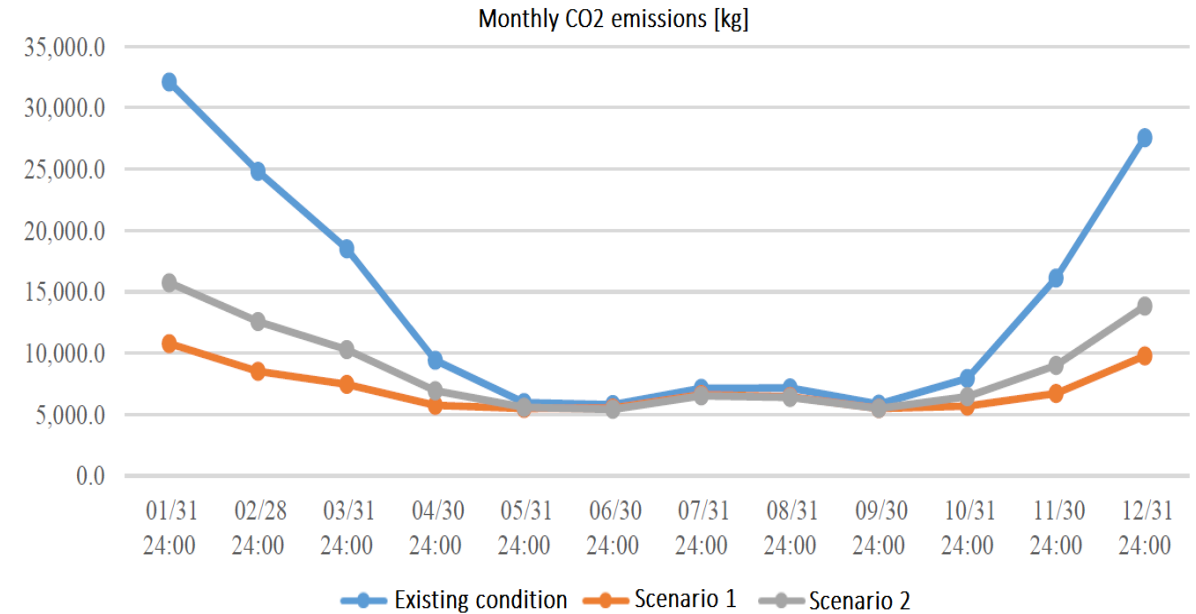
Comparisons of monthly **CO2 emissions** between actual scenario and improved scenarios

Key indicators	Existing condition	Scenario 1	Scenario 2
Heating energy [kWh]	27 685	8 765.7	18 105
Electricity heating energy [kWh]	6 133.5	2.96	43.9
Electricity cooling energy [kWh]	865.5	646.2	552.6
Total electricity energy [kWh]	16 157	9 736	9 693
CO ₂ emissions [kg]	14 022.5	7 017.9	8 683
PM10 particles [kg]	1.3	0.7	0.8
